Manhole Inspection Summary

Manhole # S25I__002MH

Insp Date: **3/11/09 12:02 PM**

Location Address: **35 LOMBARD-BOYD-ALLEY**

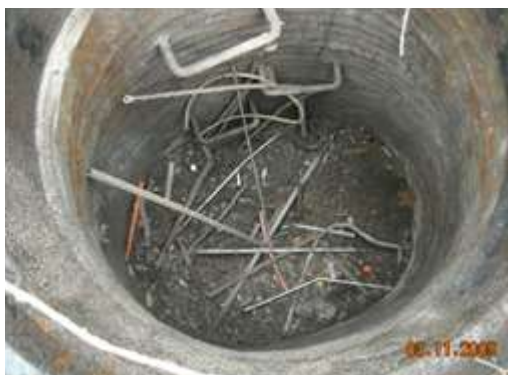
Defect 3

Condition: ☐ Sound ☐ Cracked ☐ Root Intrusion ☐ Deteriorated ☐ Leaks ☒ **Debris**

DEBRIS IN TERMINAL CHANNEL

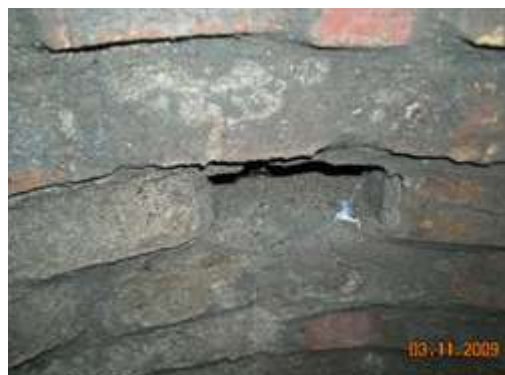
Defect 2

Condition: ☐ Sound ☐ Cracked ☐ Root Intrusion ☒ **Loose Brick** ☐ Deteriorated

LOOSE/MISSING CORBEL BRICK

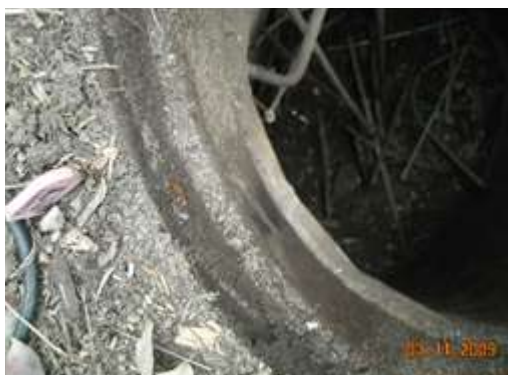
Defect 1

Frame Offset: **1** (in.) Condition: ☒ Sound ☐ Cracked ☐ Leaks

FRAME OFFSET

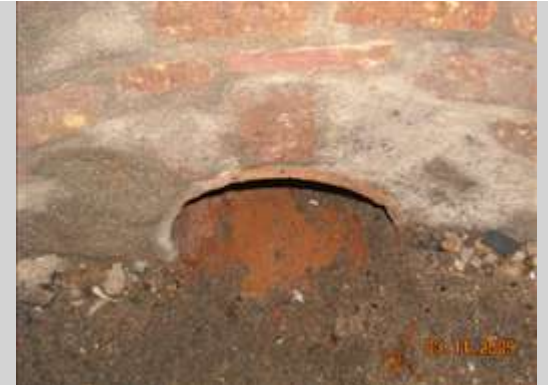
12 O'Clock Outflow

8 in. Circular Gravity Sewer
Pipe Out @ 12 O'Clock

Pipe Height: **8.4** (in.) Rod and Bar (Angled)

Pipe Material: **Clay** ☐ Pipe Lined

Invert Depth: **6.68** (ft.) Flow Characteristics: **None**

Deposits: ☒ None ☐ Mud ☐ Sludge ☐ Debris ☐ Grease

Infiltration: **None** Pipe Seal Cond: **Sound**
